# HISTORIC RESOURCES INVENTORY

## TOWN OF SUFFIELD CONNECTICUT

2016

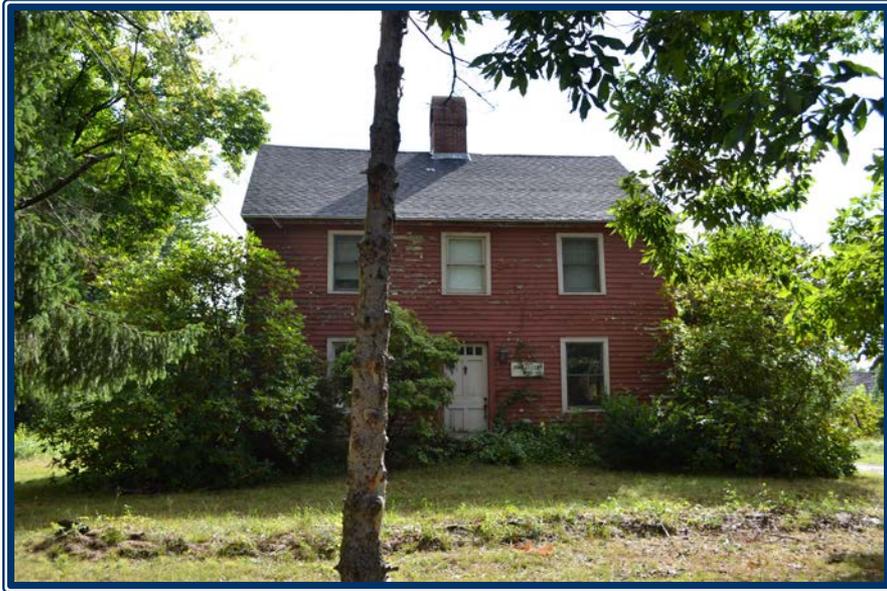
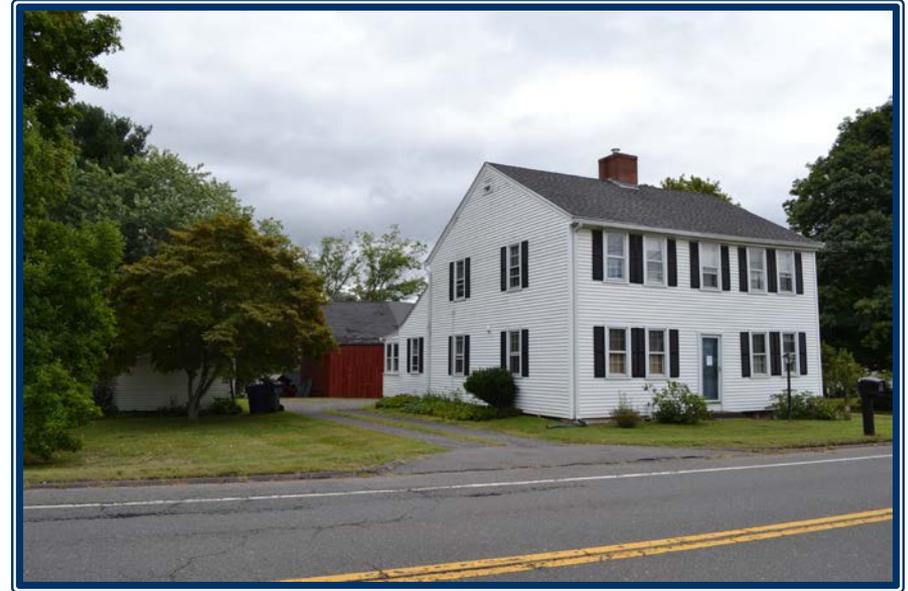
# New England Farmhouse (1650-1850)

916 East Street South – ca. 1745

8 East Street North – ca. 1813

- Typically two stories.
- Side gabled roof.
- Center chimney.
- Centered front door with some decorative moldings.
- Windows aligned in symmetrical rows.

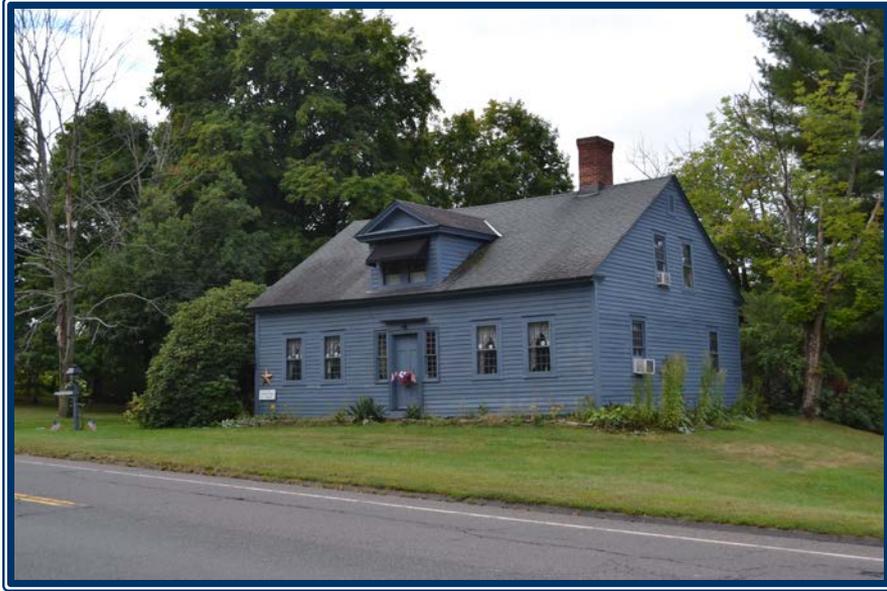
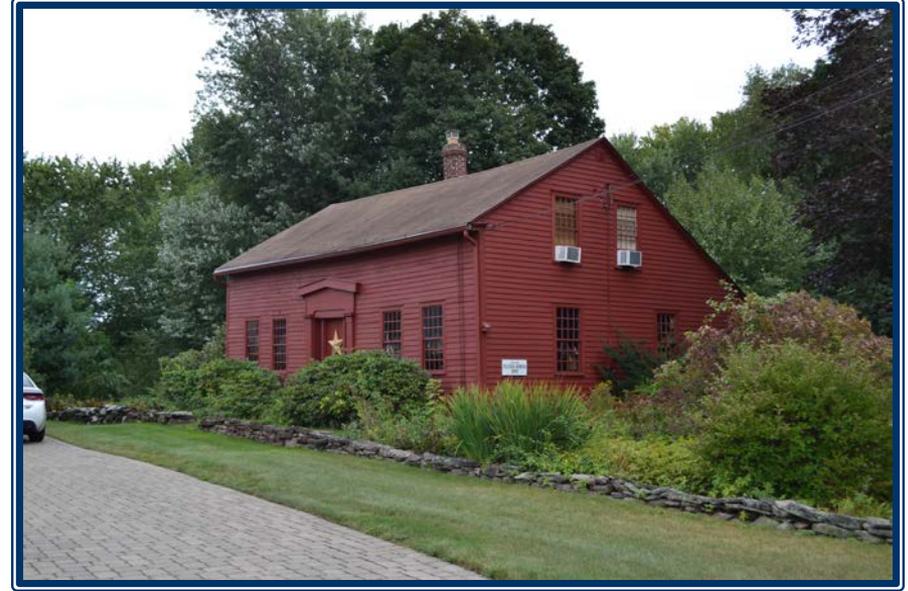
# Cape Cod (1700-1850)

611 East Street North – ca. 1805

921 Thompsonville Road – ca. 1792

- **One to one-and-a-half stories in height.**
- **Side-gabled roof.**
- **Typically centered front door with decorative moldings.**
- **Centered chimney.**
- **Windows typically aligned in symmetrical rows.**

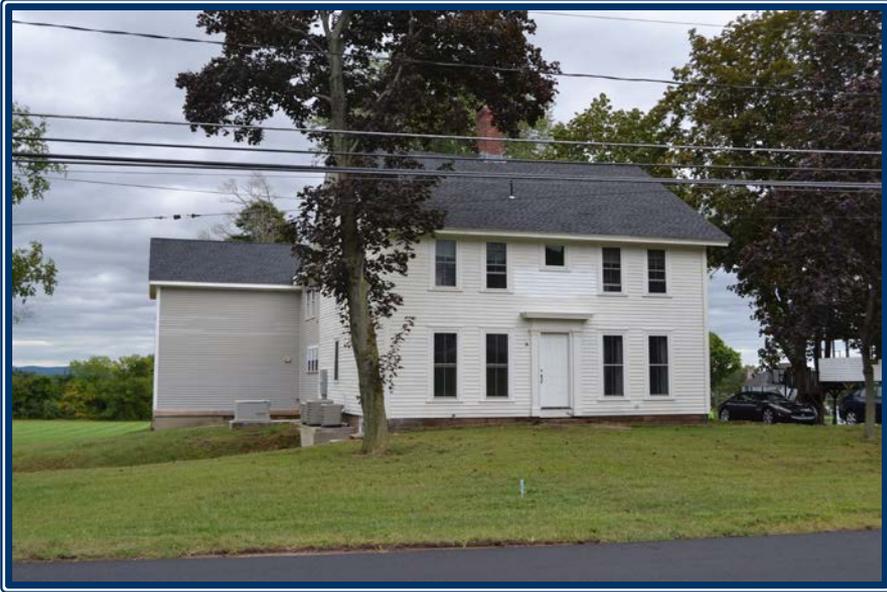
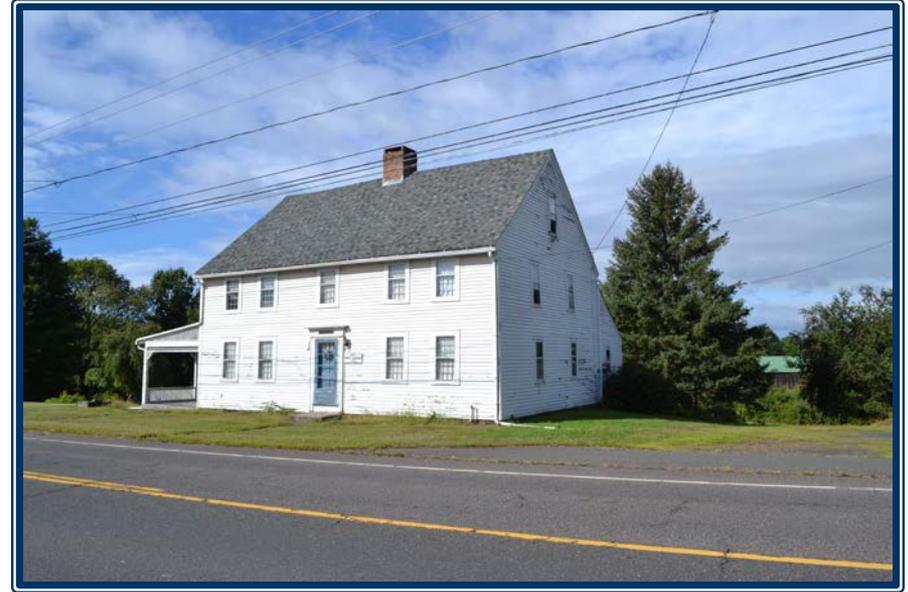
# Georgian (1700-1800)

1136 Mapleton Avenue – ca. 1806

995 East Street South – ca. 1752

- **Side-gabled roof.**
- **Center chimney.**
- **Centered front door with more elaborate moldings than N.E. Farmhouse.**
- **Windows arranged symmetrically.**
- **Occasional double doors (Connecticut River Valley Variation).**

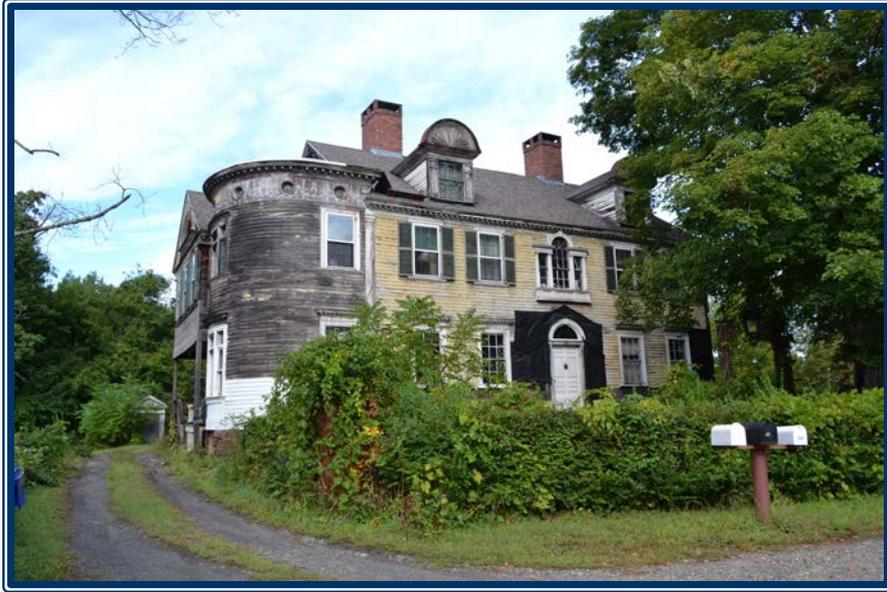
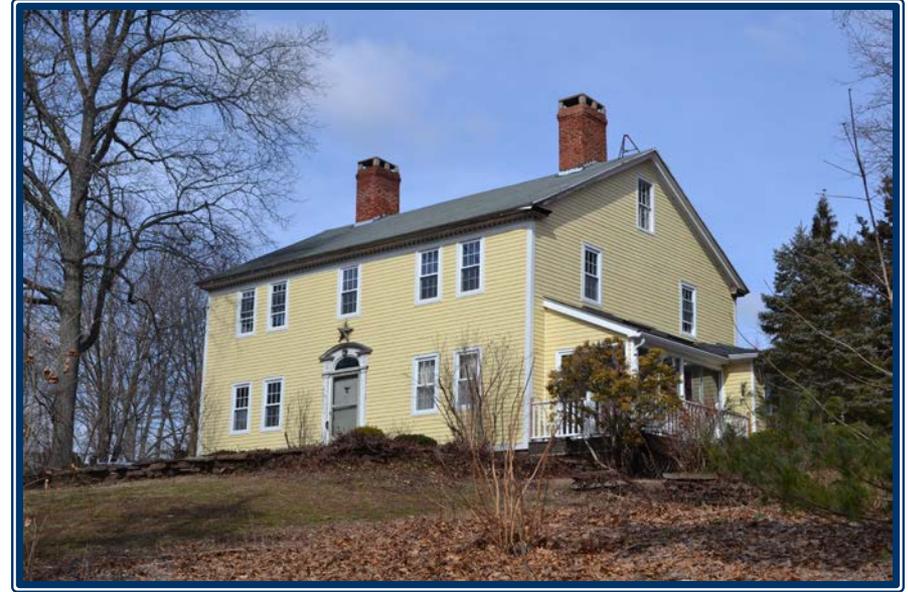
# Federal (1780-1840)

**537 Boston Neck Road – ca. 1828**

**1066 Paper Street– ca. 1790**

- **Side-gabled roof.**
- **Twin chimneys.**
- **Windows arranged symmetrically.**
- **Semi-circular fanlight over front door.**
- **Elaborate door surrounds.**
- **Cornice emphasized with dentil or other moldings.**

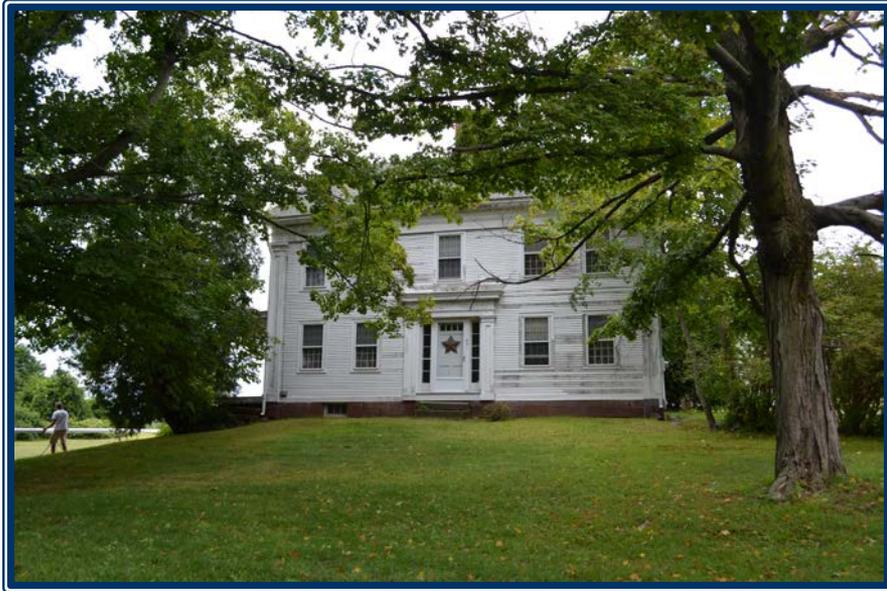
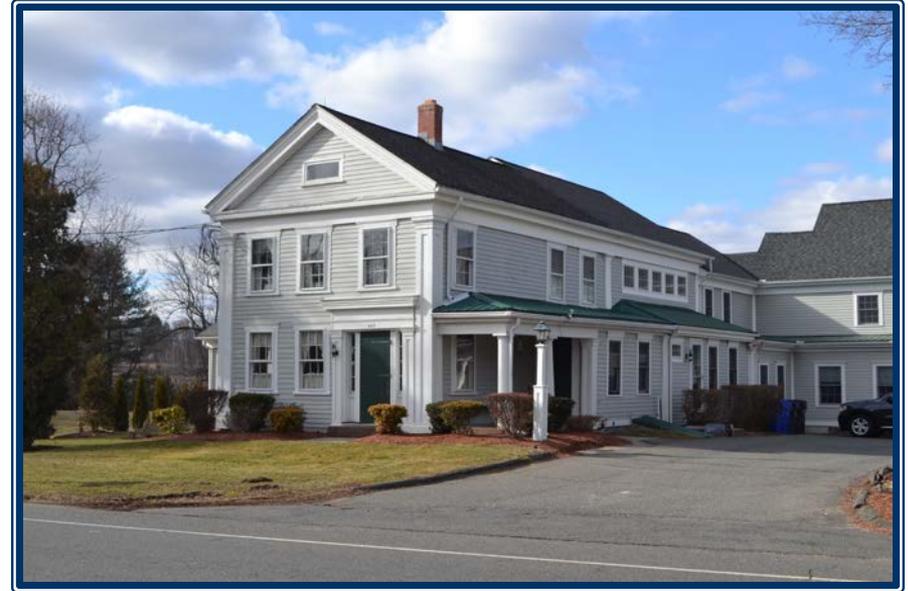
# Greek Revival (1825-1860)

831 Mapleton Avenue – ca. 1809

449 Mapleton Avenue – ca. 1850

- Typically front-gabled, low pitched roof.
- Frieze band at cornice.
- Corner pilasters.
- Elaborated door surround.
- Porch supported by heavy columns.

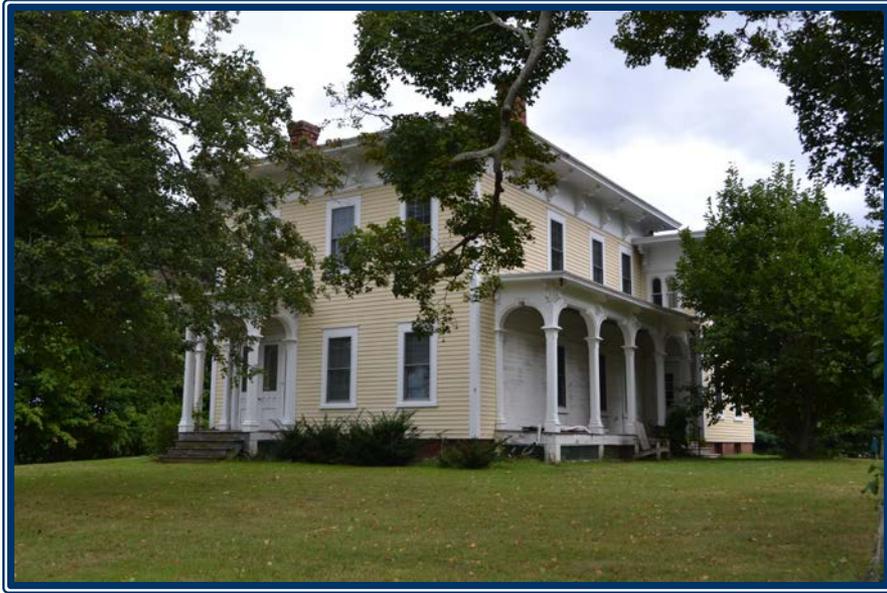
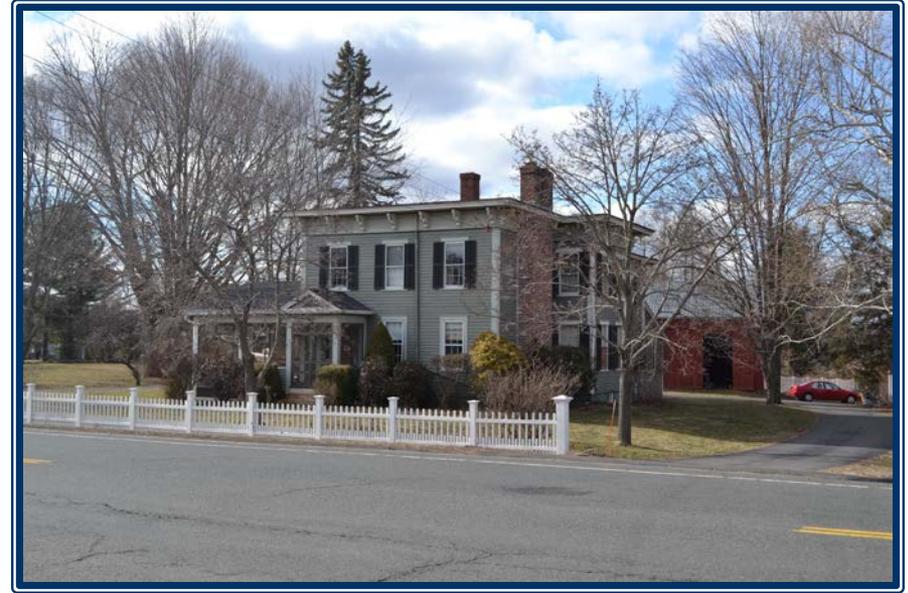
# Italianate (1840-1885)

768 Mapleton Avenue – ca. 1860

595 Mapleton Avenue – ca. 1860

- **Inspired by rambling, informal Italian farmhouses.**
- **Two or three stories in height, some with cupolas or towers.**
- **Low pitched or flat roof.**
- **Wide overhanging eaves and cornices with brackets.**
- **Arched or double-arched windows, often with elaborate crowns.**

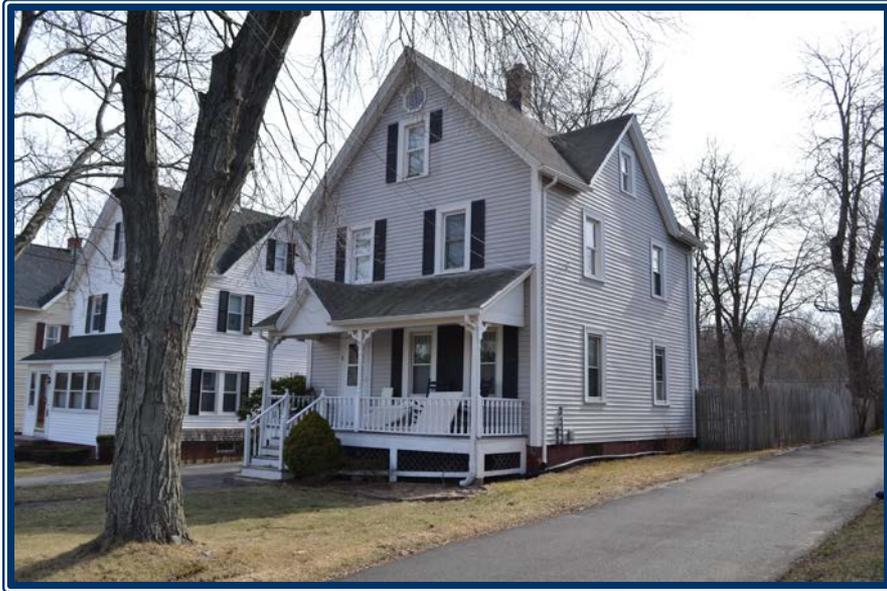
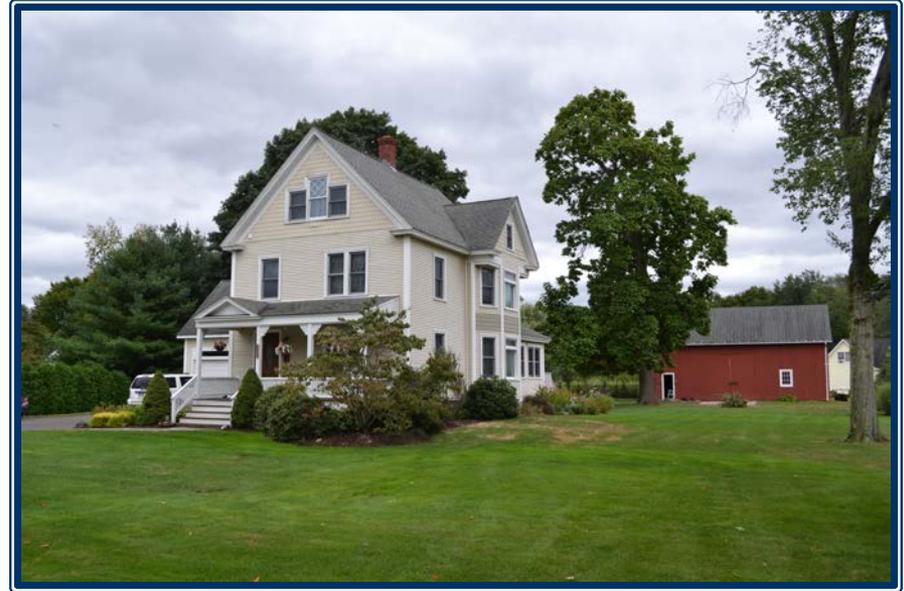
# Queen Anne (1880-1910)

111 Bridge Street – ca. 1900

1390 Mapleton Avenue – ca. 1905

- English revival style inspired by late Medieval forms.
- Steeply pitched hipped or gable roof.
- Dominant front facing gable.
- Corner towers or turrets.
- Patterned shingles.
- Partial or full-width porch.

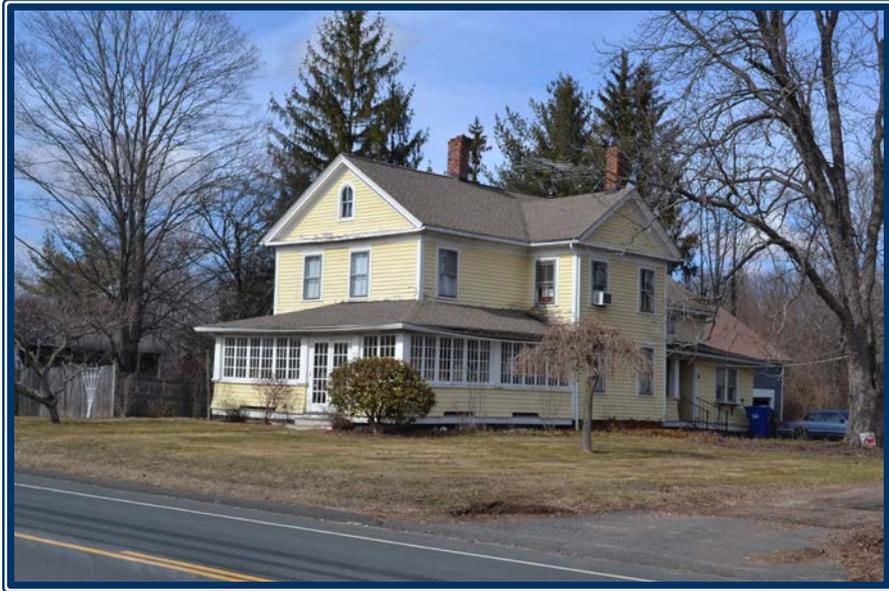
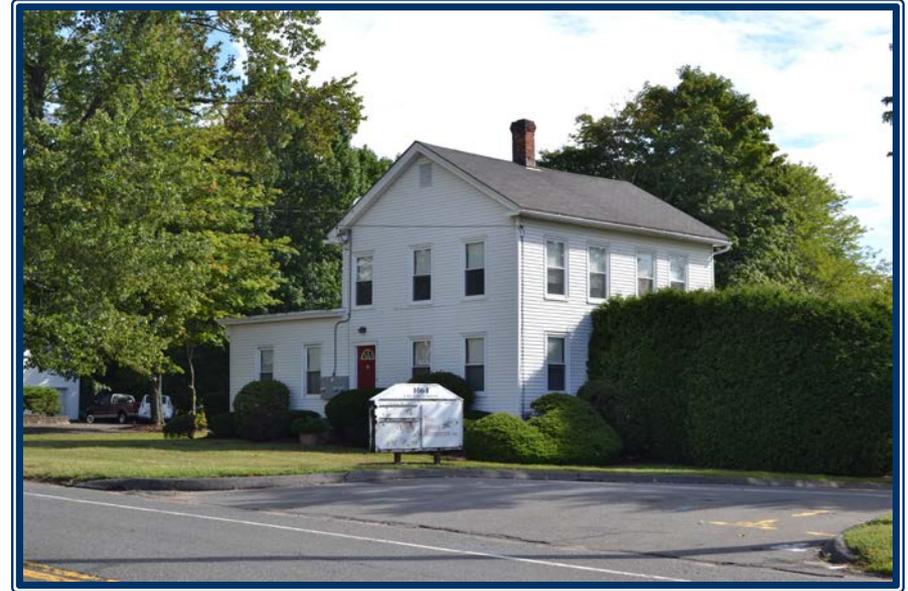
# Vernacular (1860-1930)

312 Bridge Street – ca. 1878

1064 East Street South – ca. 1860

- Influenced by high-style forms.
- Less elaborate.
- Little ornamentation.

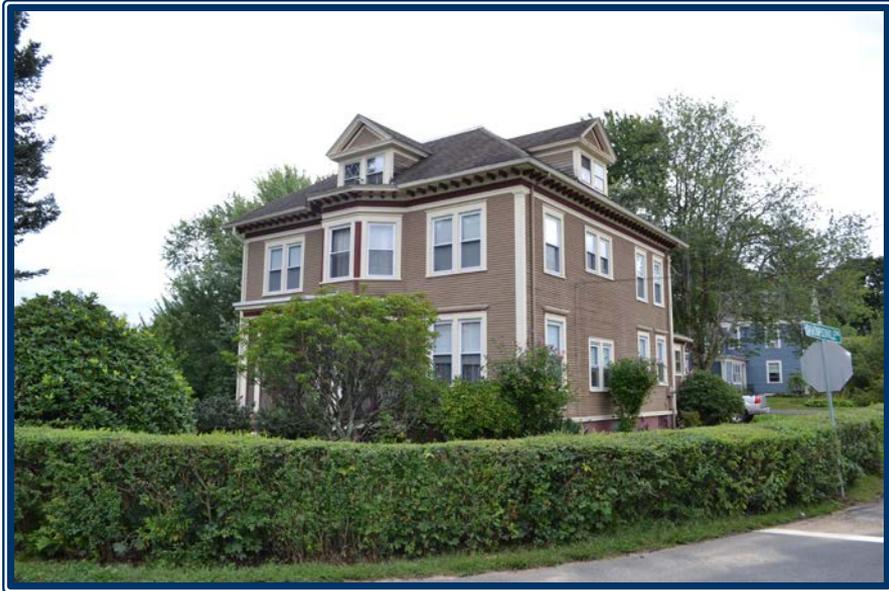
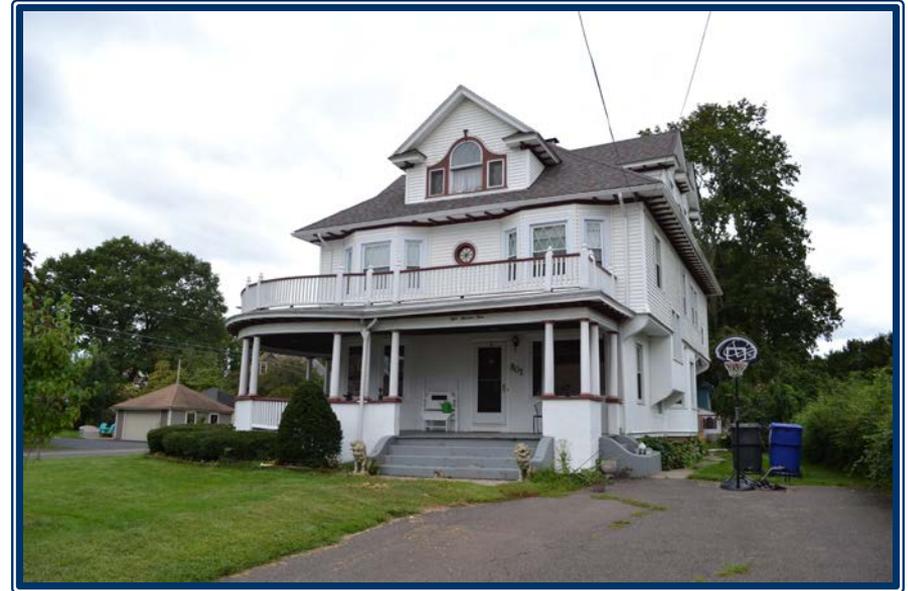
# Colonial Revival (1880-1955)

955 Thompsonville Road – 1909

803 River Boulevard – ca. 1900

- Influenced by Georgian, Dutch Colonial and other early American forms.
- Side-gabled or gambrel roofs.
- Accentuated front door and dormers.
- Symmetrical door and window placement.

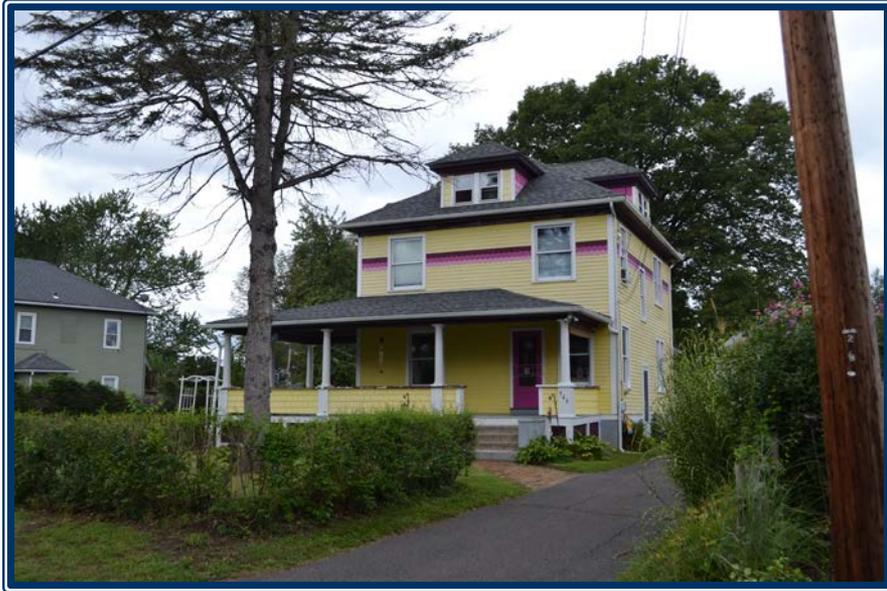
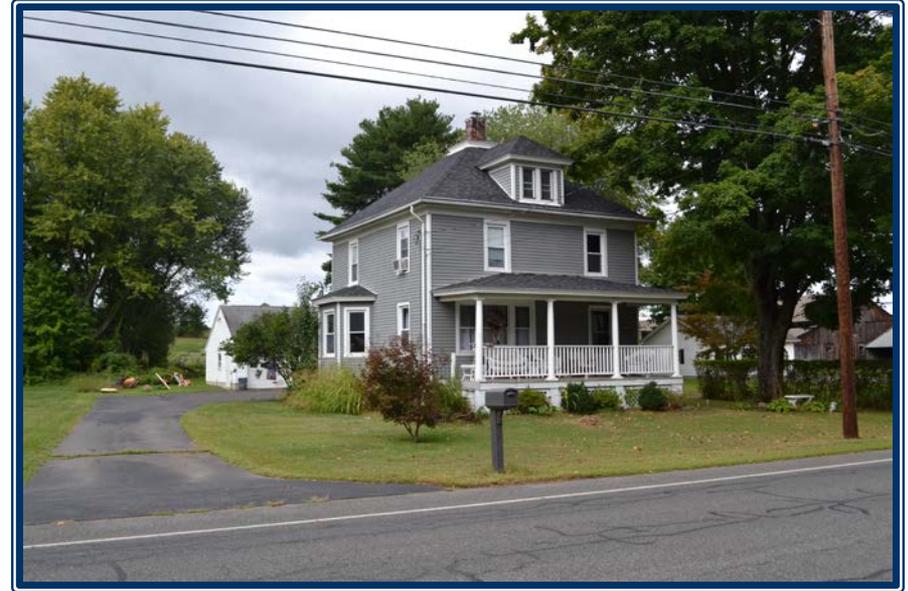
# American Foursquare (1890-1940)

946 Thompsonville Road – ca. 1921

927 East Street North – ca. 1900

- **Variation of the Colonial Revival style, related to Wright's Prairie style.**
- **Square, boxy footprint and massing.**
- **Hipped roof.**
- **Dormers.**
- **Prominent front porch.**
- **Occasionally wood trim or other Craftsman-style decorative details.**

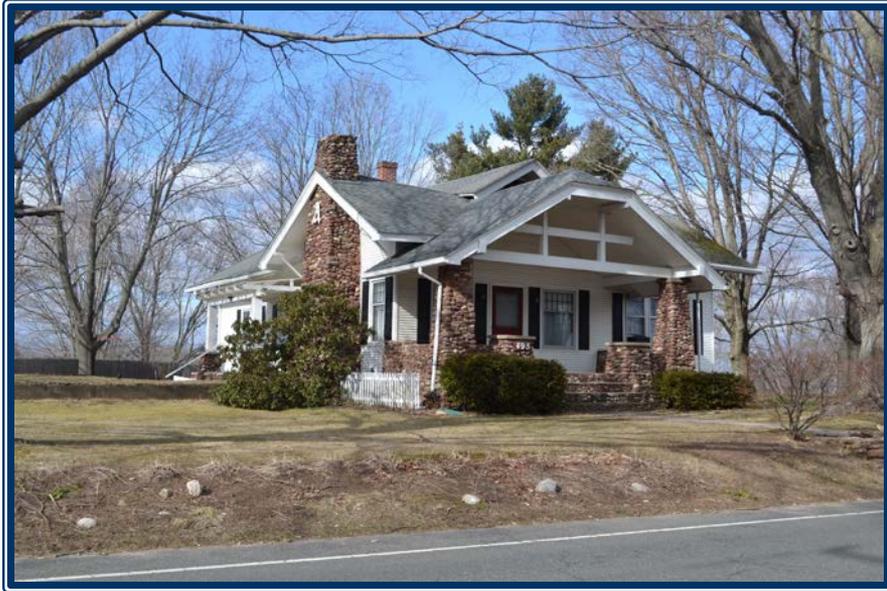
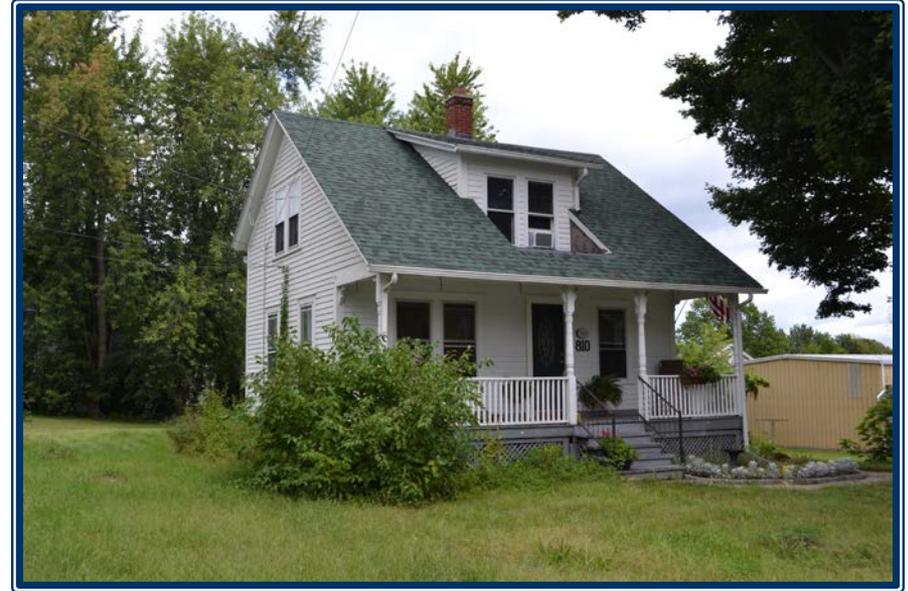
# Craftsman/Bungaloid (1905-1940)

495 Mapleton Avenue – ca. 1935

810 Thompsonville Road – ca. 1920

- **Side-gabled roof, often extending over a front porch.**
- **Wide eave overhangs.**
- **Exposed rafter tails.**
- **Prominent dormers.**
- **Porches supported by columns or piers.**

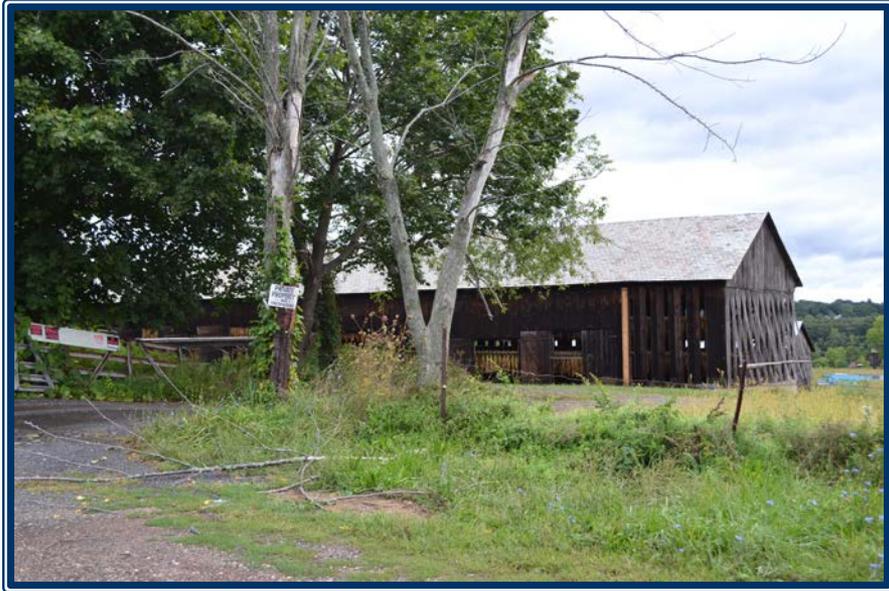
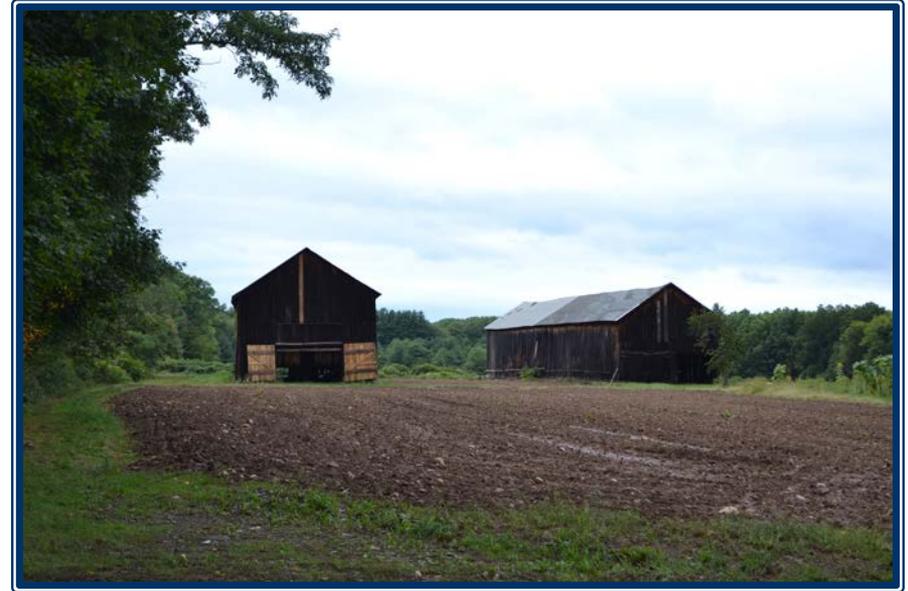
# Tobacco Shed (1900-1960)

**190 East Street North – Early 20<sup>th</sup> c.**

**137 East Street South – Early 20<sup>th</sup> c.**

- **Long, low windowless plan.**
- **Pitched front-facing gable roofs.**
- **Doors at each end of building.**
- **Comprised of a series of “bents,” each approximately 15 feet deep.**
- **Various venting systems for drying tobacco leaf, most commonly vertical top- or side-hinged boards running along eave sides.**
